FEASIBILITY STUDY TO PRODUCE SOUND BARRIER
BRICK USING CRUMB RUBBER

CIVIL ENGINEERING
UNIVERSITI TEKNOLOGI PETRONAS
JUNE 2010

Dissertation submitted in partial fulfilment of
the requirements for the
Bachelor of Engineering (Hons)
(Civil Engineering)

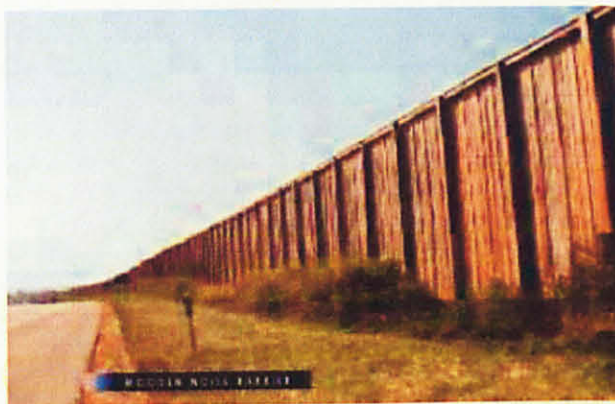
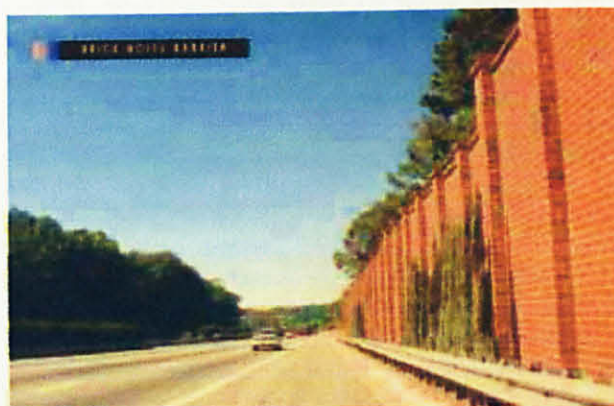
Figure 1.2: Some types of barrier wall

First of all, the noise barrier is defines as solid obstructions built between highway and residential area [2]. It cannot block all the noise; however reduce the noise level by 5 to 10 decibels (dB). It can be effective depending on the material used. There are many types of barrier such as concrete barrier, wood barrier, timber barrier, earth berm barrier, and others (Figure 1.2). The common type is concrete barrier as it satisfied the noise reduction parameter. The new introducing of crumb rubber in brick to be applied for noise barrier is a great opportunity to highway technology. The material is a waste product that has been recycled to produce a new end product. Therefore, the new brick barrier can reduce the sound while encouraging to a greener world.

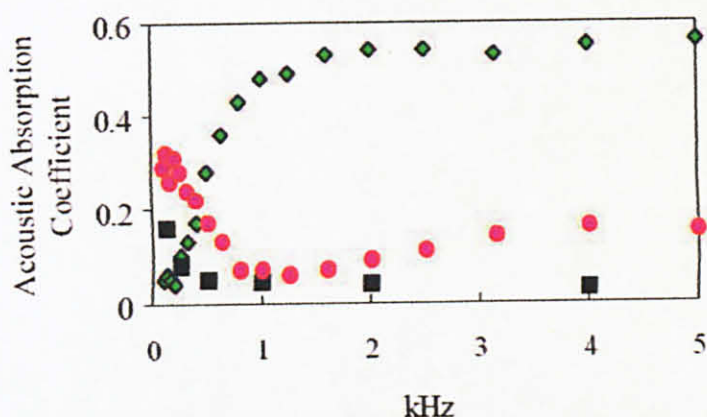
filled with crumbed rubber [4]. Figure 2.1 shows the result of the experiment and it is proved that crumb rubber based product has greater acoustical absorption compared to other materials [4].

Figure 2.1: Acoustic absorption coefficient versus frequency [4]
 Legend: ■ Concrete barrier ● Carsonite barrier ◆ Crumb rubber mix

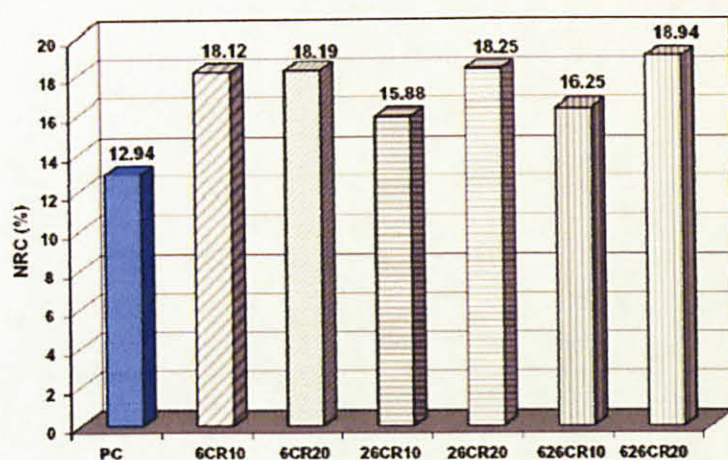
frequency than plain concrete which suitable for highway application. The noise reduction coefficient is displayed in the Figure 2.2. It is indicated that crumb rubber is 36 % greater sound resistance properties than plain concrete [5].

Figure 2.2: Noise reduction coefficient [5]

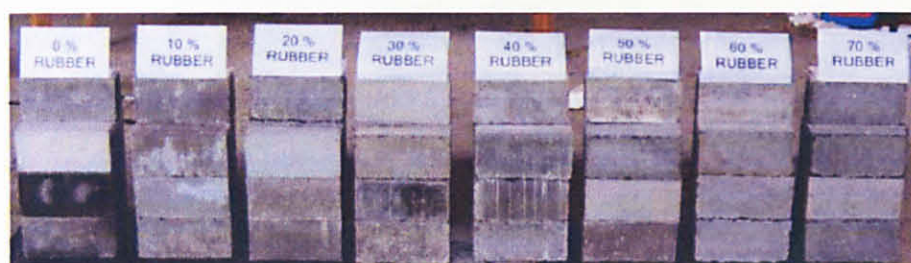
The appearances of eight brick samples including control mix were shown in Figure 2.3. The investigators found that the more crumb rubber added, the better the brick appearance [6]. There are other tests conducted by them on water absorption, compressive strength, and flexural strength which conformed to ASTM C 67-03a [6]. They concluded that the replacement of crumb rubber as aggregate in mix proportion reduces about 29 % unit weight of the brick [6]. High percentage replacement of crumb rubber with conventional sand does not exhibit sudden brittle fracture means that the energy absorption capacity is high.

Figure 2.3: Appearance of brick sample [6]

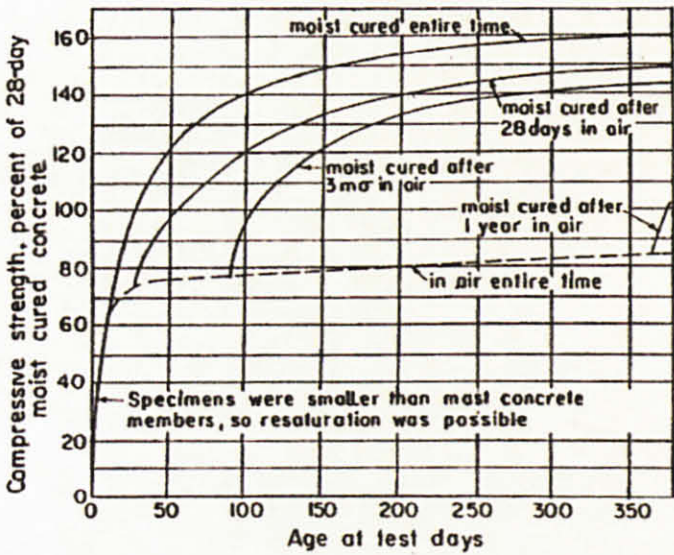
interrupted curing process compared to the stone aggregate concrete. It is significant to conclude that the strength of the specimen increased when the curing process beyond 28-day as shown in the Figure 2.4.

Figure 2.4: Effect of curing conditions on compressive strength of stone aggregates concrete [7]

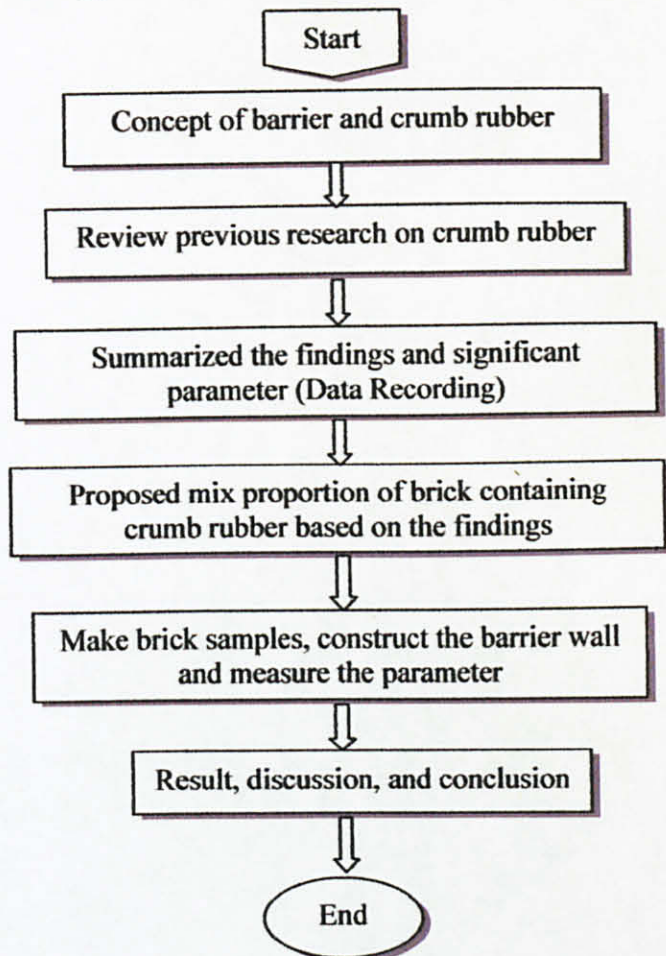
Figure 3.1: Methodology Flow Chart

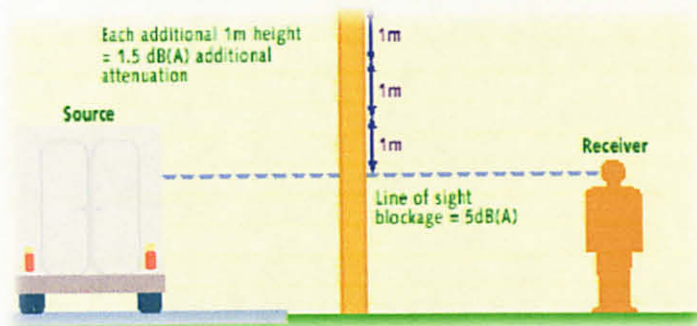
A noise barrier can reduce 5 dB noise level when its height is exceeded the line of sight of the receiver. As it exceeded the line, the reduction of noise is about 1.5 dB for each meter of barrier height as shown in Figure 3.2.

Figure 3.2: Concept of noise barrier [2]

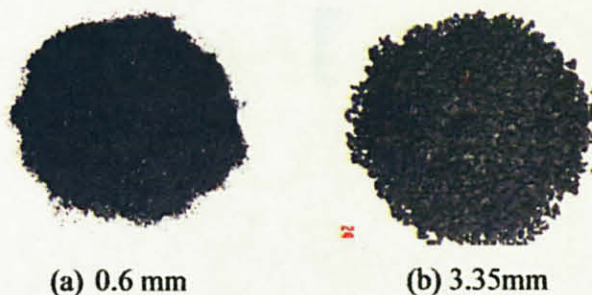
Based on the journals reviewed, the author chose two different sizes of crumb rubber which are; 3.35 mm and 0.60 mm as shown in Figure 3.3. The reason of selecting that particular size is due to the greater noise reduction compared to other size. The amount of crumb rubber that used for a brick is about 403g which represented 40 % replacement of sand used to make a brick sample. The percentage was chosen as it was proved that 40 % replacement of sand to crumb rubber will give greatest slump value compared to other percentage.

Figure 3.3: Crumb rubber

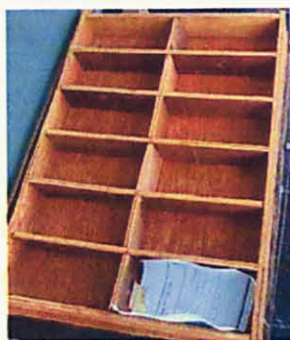
Figure 3.4 shows the formwork that was made from plywood and has a dimension of 105 x 75 x 225 mm per sample. For the cube testing purpose, two steel moulds with dimension 100 x 100 x 100 mm were used. Basically, the formwork and the steel moulds were greased first before placing the fresh mixes to ease the dismantling process later.

Figure 3.4: Formwork for 12 samples

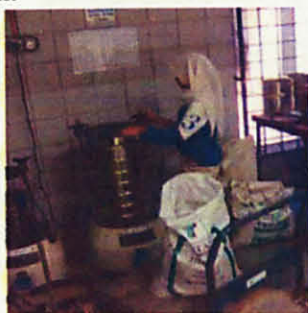
Prior to brick manufacturing, the materials such crumb rubber and sand were graded using sieve shaker before the mixing process started as shown in Figure 3.5. It was carried out to maintain the correct grading of sand that is to be used. The sieve meshes of several sizes such as 1.18 mm, 600 μm , 425 μm , 300 μm and 150 μm were used for the sand. Besides, the crumb rubber was sieved in order to obtain the required sizes which are 3.35 mm and 0.60 mm.

Figure 3.5: Sieving

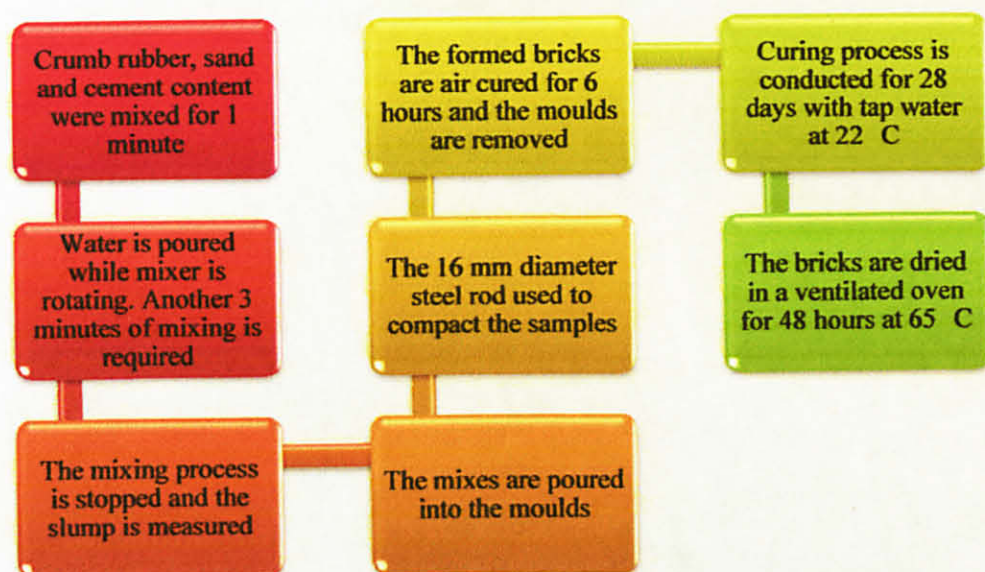
Figure 3.6: Procedure of brick making [6]

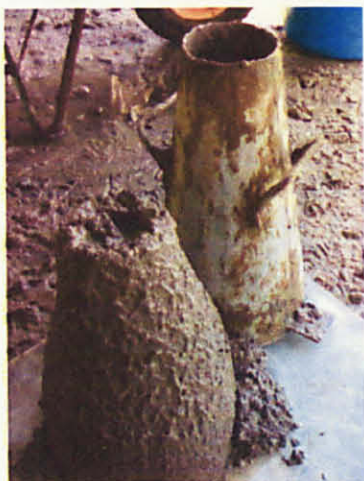
Upon to the mixing process, the slump test was conducted to measure the workability of the fresh mixes. The slump cone was filled with the mixes by three layers in which it was tamped with 25 strokes by using a tamping rod. The slump cone was removed vertically and the slump was measured by determining the difference between the height of the slump cone and the highest point of the mix that being tested as shown in Figure 3.7. The result was recorded in millimeter unit and will be discussed further in the next chapter.

Figure 3.7: Slump test

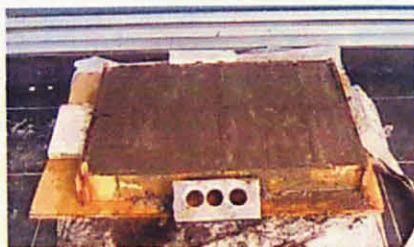
The fresh mix was poured into the formwork that has been prepared earlier and compacted by using steel rod to remove the air trap. Figure 3.8 displayed the casting of 12 samples. The formwork was dismantled after 24 hours air-cured process.

Figure 3.8: Casting

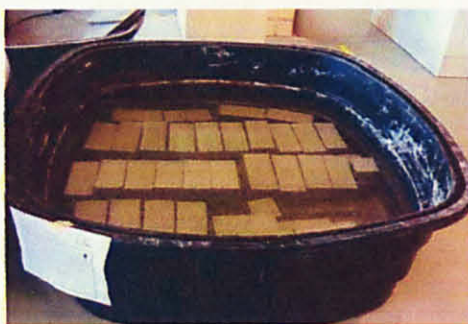
The physical properties of concrete mostly depend on the extent of hydration of cement during curing process. It is the mechanism in which the cement will harden and impart the strength of the concrete simultaneously. Curing process took place for 28 days in a cure tank, filled with 22 °C of tap water as shown in Figure 3.9.

Figure 3.9: Curing tank

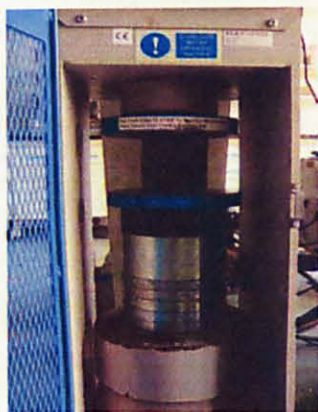
After the curing process took place, the samples were tested for compressive strength to measure the strength. The samples were dried first before the test started as the compression test machine is sensitive to the present of water. The compressive strength was determined by dividing the maximum load with the applied load area which is 100 mm x 100 mm of the cube samples as can be seen in Figure 3.10.

Figure 3.10: Cube compressive strength

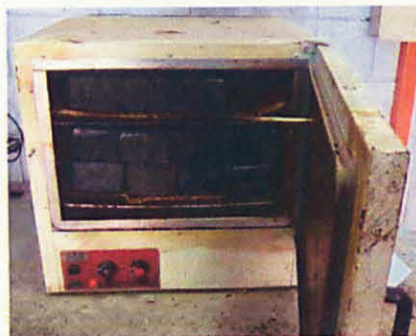
The final step in making the brick was the oven-dried process whereby the brick samples were dried for 48 hours in a ventilated oven at 65°C temperature as shown in Figure 3.11. After 48 hours period, the bricks were removed from the oven and ready to be used for the barrier wall.

Figure 3.11: Oven-dried process

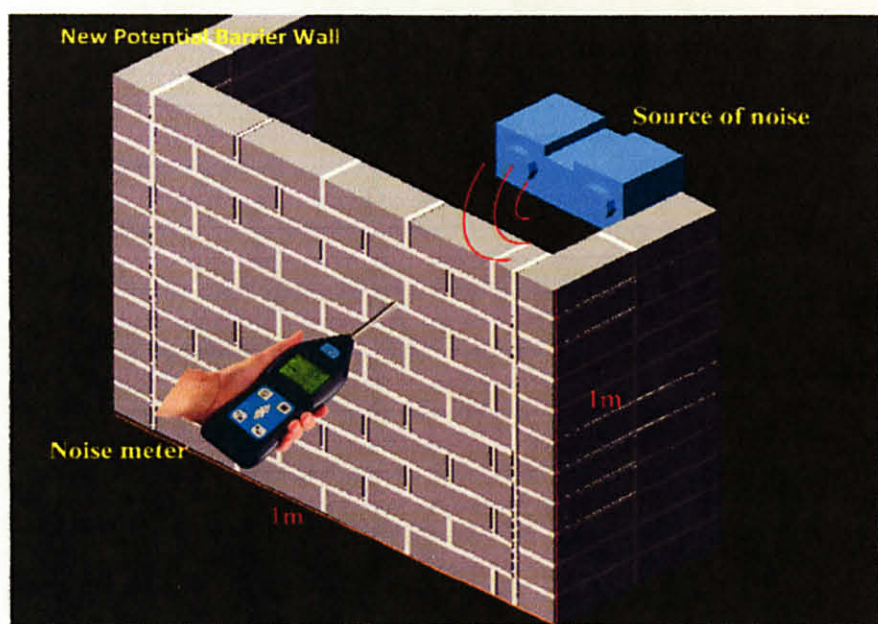
The experimental set-up of the barrier wall is displayed in Figure 3.12. The wall is built in 1 m width x 1 m height with each brick dimension is 105 x 75 x 225 mm. The additional barrier is constructed for both sides to allow the reflection of sound. It is also to avoid the sound from diverging to other angle which may contribute to error. The source of noise is generated behind the wall while the receiver (sound meter) placed at front of the wall. The source of noise and the receiver should be at the same level. The reduction of noise level is measured by comparing the noise level at both sides in order to test the efficiency of the barrier wall using crumb rubber-added brick.

Figure 3.12: Experimental set-up

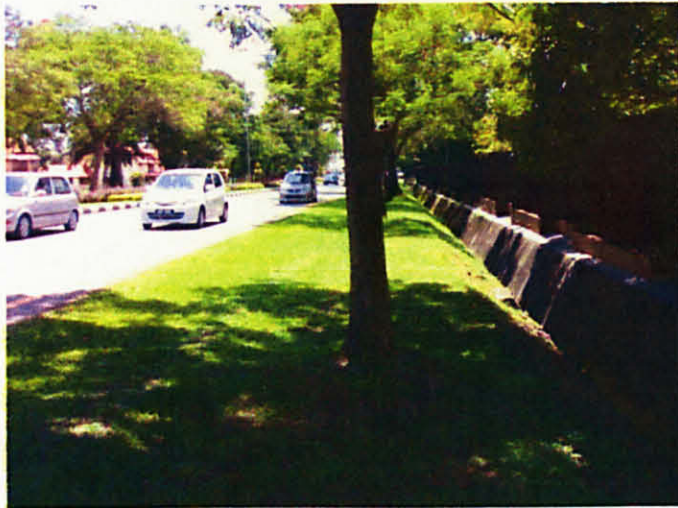
Figure 4.1: Jalan Sultan Azlan Shah

The author recorded sound level at two different locations; Jalan Sultan Azlan Shah (Refer Appendix B) and Ipoh-Utara Highway (Near to Kawasan Gunung Helang) (Figure 4.1, 4.2 and 4.3). The equipment being used was Sound Level Meter (ONO SOKKI Model LA-1240) as shown in Figure 4.4.

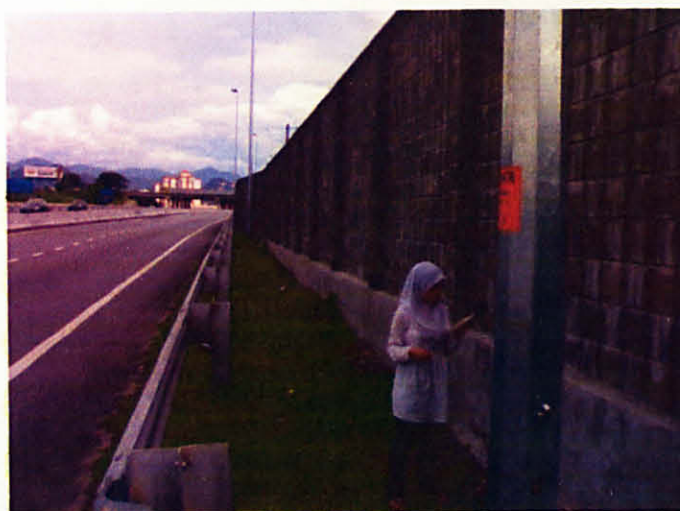
Figure 4.2: Ipoh-Utara Highway (Front Wall)

There were existing barriers at both locations whereby the heights of barrier are approximately 2 meter and 4 meter respectively. The sound level was recorded at front wall as shown in Figure 4.2. Beside that, the author also recorded sound level behind the wall at Location #2 as shown in Figure 4.3. The Location #1 is the private area whereby accessibility was prohibited or was not permitted to enter. This constraint leads to unavailable data of behind wall at Location #1. The result is shown in Table 4.3.

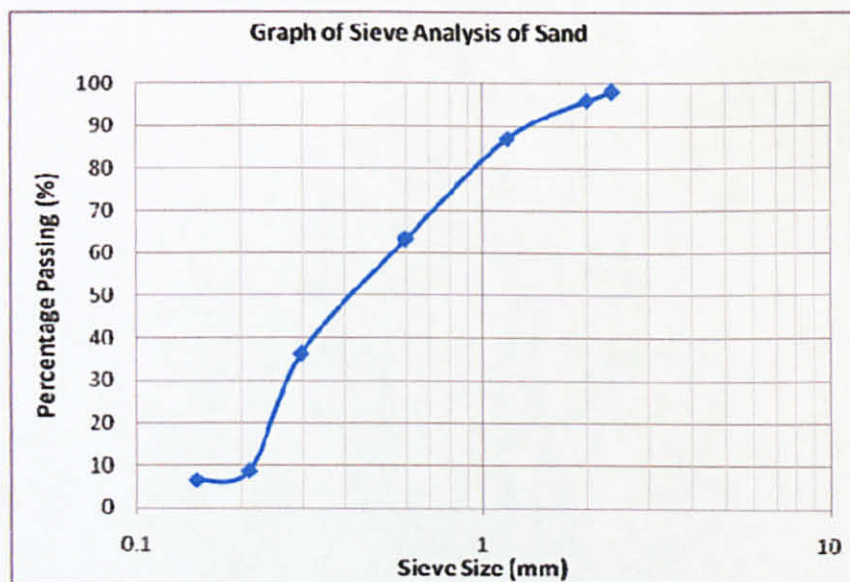
The result of sand analysis is shown in Figure 4.5. The sand was well graded with the largest size is 1.18 mm. Most of them are retained at sieve size of 0.6 mm. The sand that used in the project was not too dry to avoid from less bonding with cement during mixing process.

Figure 4.5: Sieve Analysis

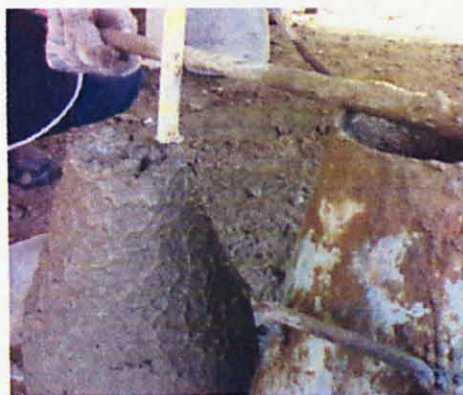
Figure 4.6 displayed the slump test that has been conducted. The measured average slump is 7.1 cm. It proved that the combination of crumb rubber sieve no.6 and 26 can produce greater slump and exceed the slump value conducted by Paki and Bulent, which is 6.5 cm [6].

Figure 4.6: Slump measurement

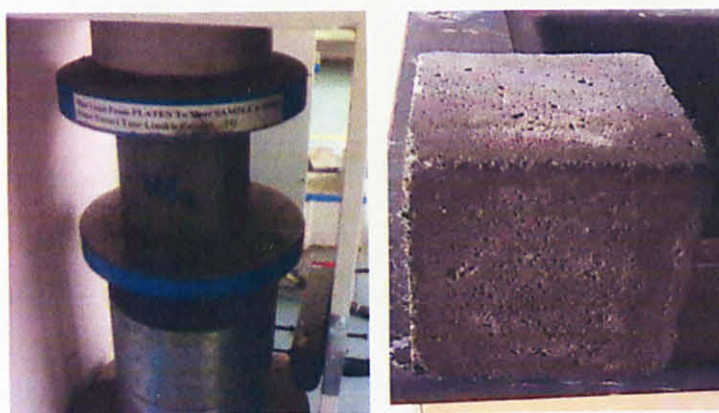
The author used 100 x 100 x 100 mm cube to test the strength as shown in Figure 4.7. The brick exhibited similar strength either it is tested by using cube or brick. The result of the compressive strength is shown in Table 4.5. The minimum compressive strength for non-load-bearing concrete masonry unit is 3.5 MPa as stated in ASTM C129 [11]. The strength of the new crumb rubber-added brick is 5.36 MPa whereby it exceeded the required strength stated in the standard.

Figure 4.7: Cube testing

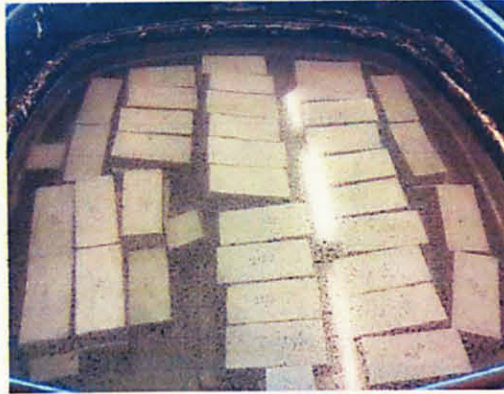
After dismantling the formwork, the bricks were cleaned and ready to be cured. The tap water has been used as the pH of the tap water is 7.5; natural pH standard. The curing process was selected to be 28 days as the strength of the bricks are higher compared to 7 or 14 days [7]. The curing process can be viewed in Figure 4.8.

Figure 4.8: Curing process

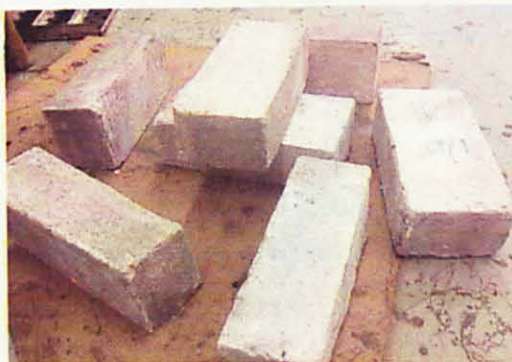
Once the bricks finished the curing process, the bricks were dried into oven for 48 hours with temperature 65°C . The appearances of the dried-brick after removing from oven were shown in Figure 4.9.

Figure 4.9: Dried-brick appearance

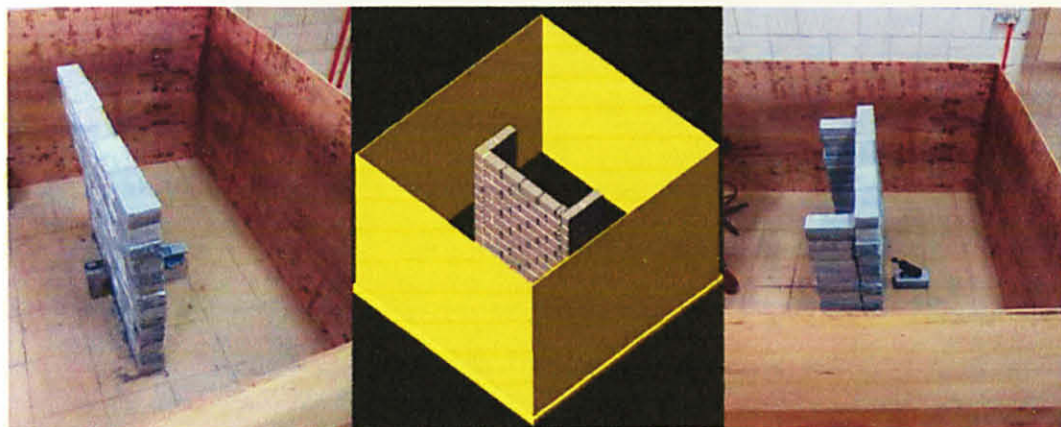
Upon the completion of brick making, a sound barrier wall was constructed in the laboratory by using the crumb rubber-added bricks as shown in Figure 4.10. The wall was barricaded by plywood to avoid the noise to be diverted and decay.

Figure 4.10: Sound barrier wall

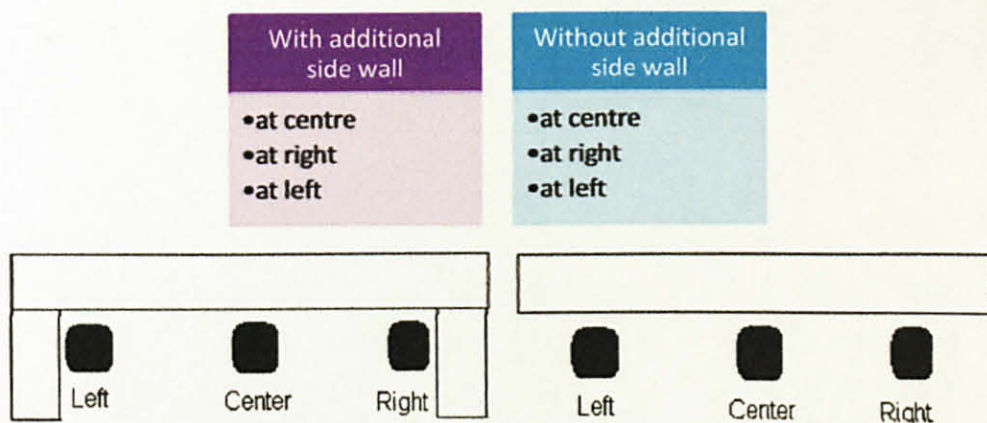
There were several attempts that had been conducted in order to measure the efficiency of the new barrier wall at different locations as stated in Figure 4.11.

Figure 4.11: Method of noise measurement

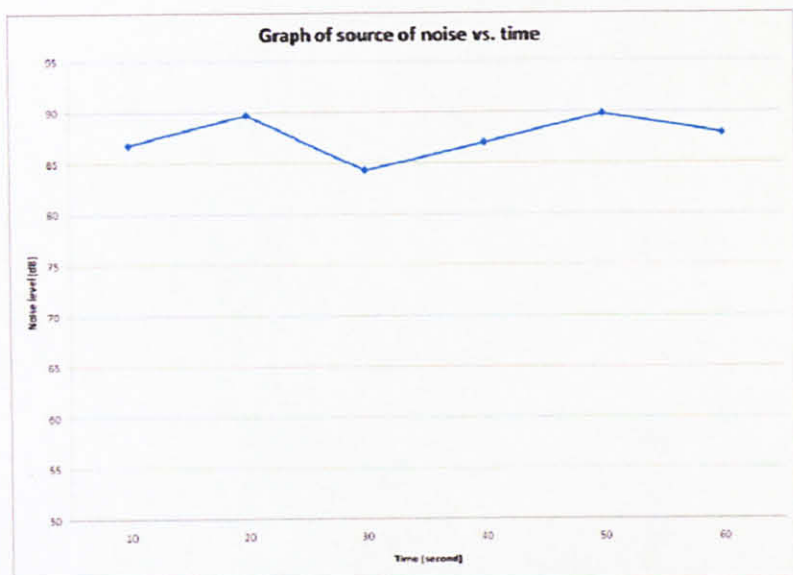
Initially, the source of noise was recorded to create similar noise level that taken during field measurement. The result of source of noise can be seen in Figure 4.12.

Figure 4.12: Graph of source of noise vs. time

Based on the above graph, the loudest sound created almost 90 dBA while the average of noise in 60 seconds is about 88 dBA. The author used the same source of noise which is recorded sound for each kind of trial.

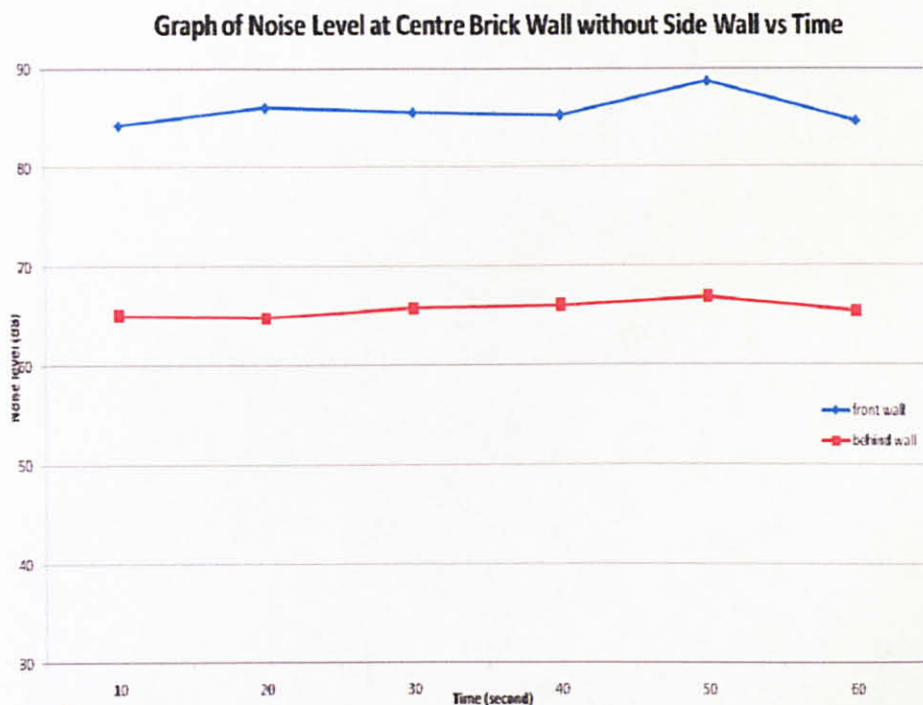
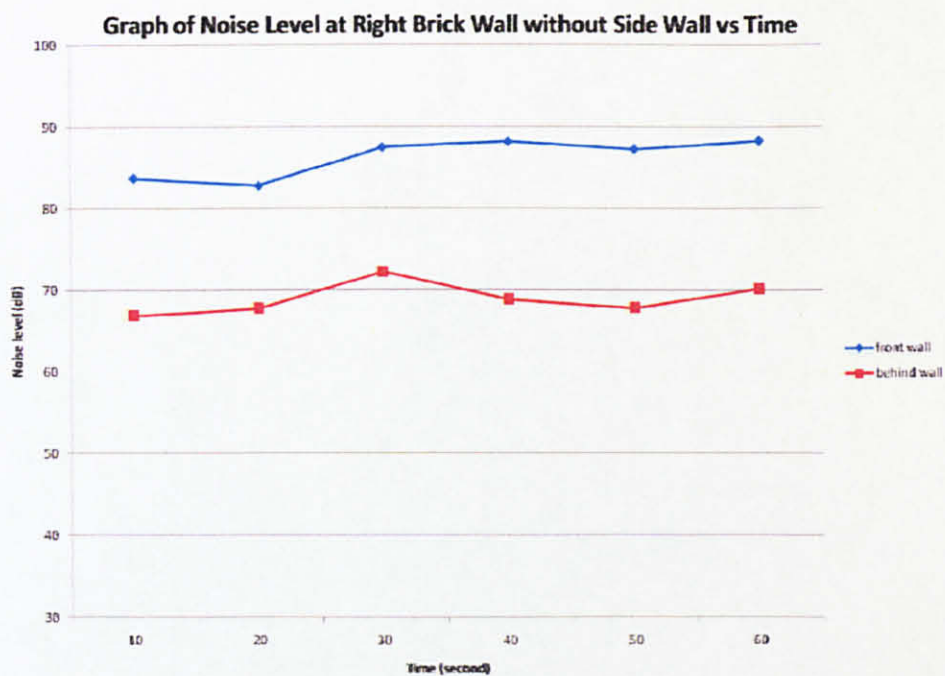
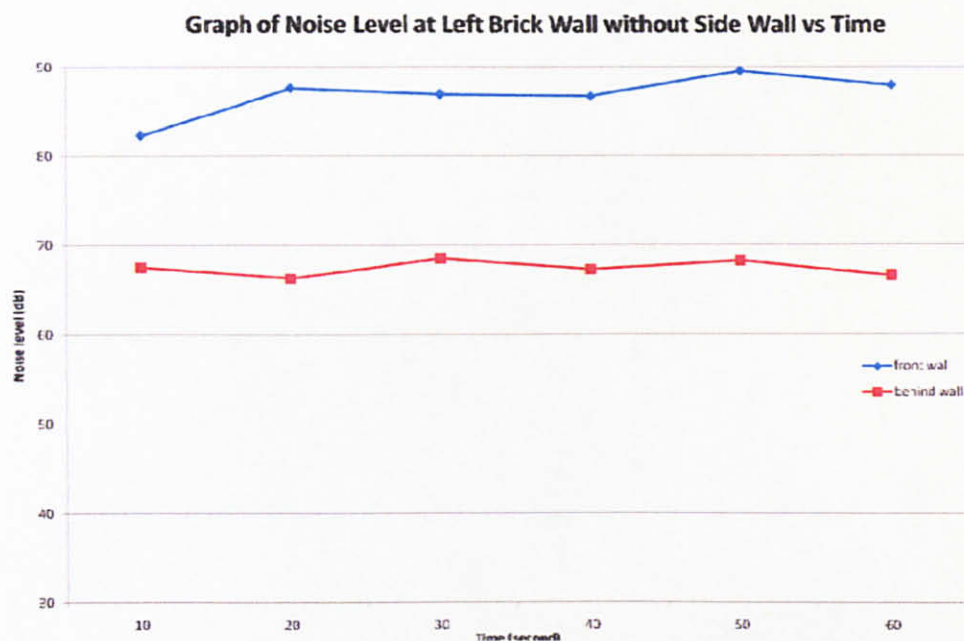
The first attempt was to measure the noise reduction of barrier wall without additional side wall. The source of noise and the noise meter (receiver) were aligned at the same level. The location of the source of noise and also the noise meter (receiver) were manipulated at 3 different locations namely; centre, right, and left of wall. The results for the three experiments were shown in Figure 4.13 until 4.15.

Figure 4.13: Graph of noise level at centre brick wall without side wall vs. time

Figure 4.14: Graph of noise level at right brick wall without side wall vs. time

Figure 4.15: Graph of noise level at right brick wall without side wall vs. time

It can be said that the noise level at front wall for three different locations is below 90 dBA. The noise is not directly reflected back to the wall as it spread to other angle. The average of noise reduction for barrier wall without additional side wall is about **18.87 dBA**.

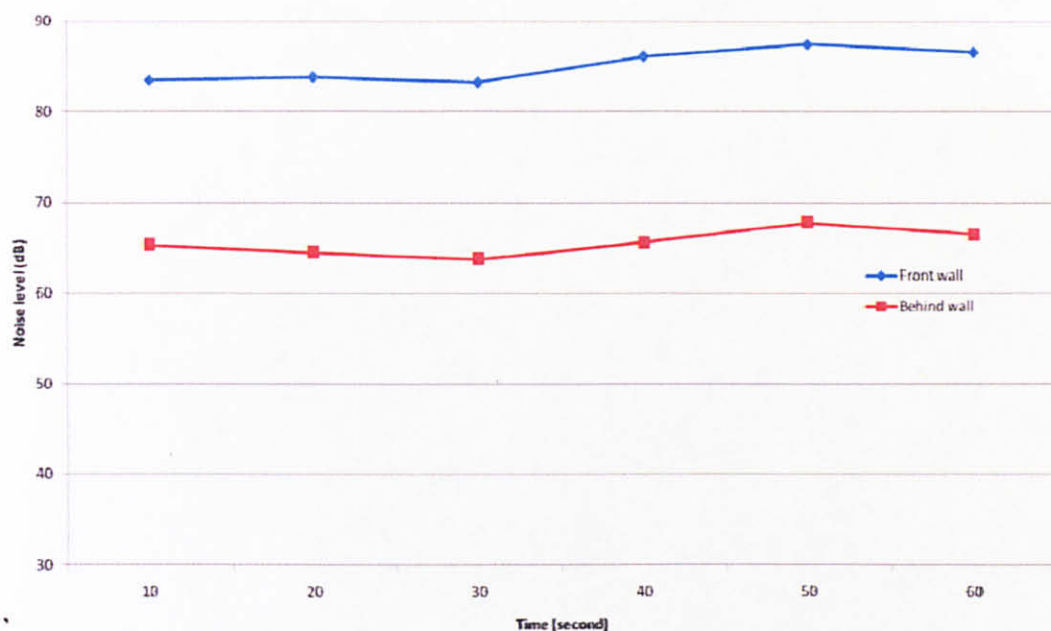
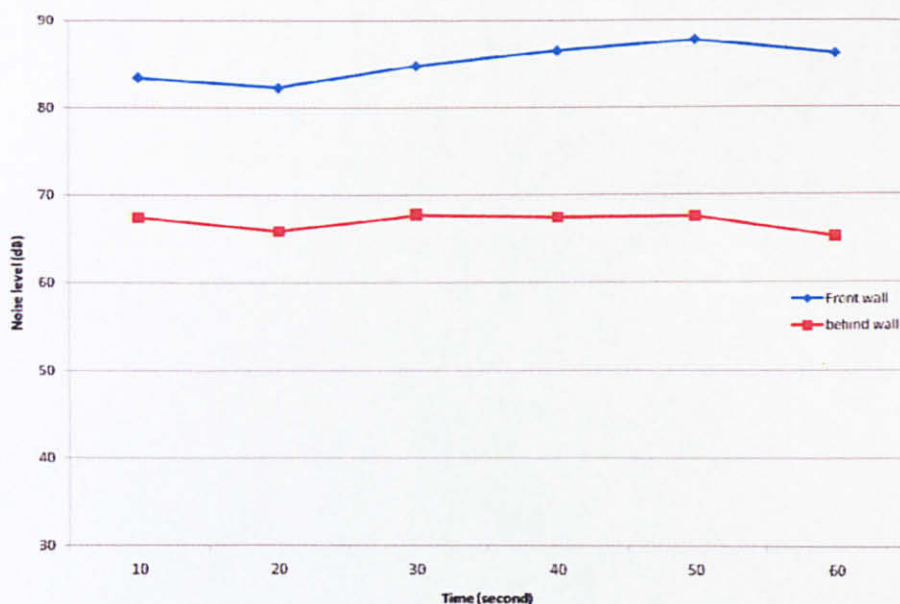
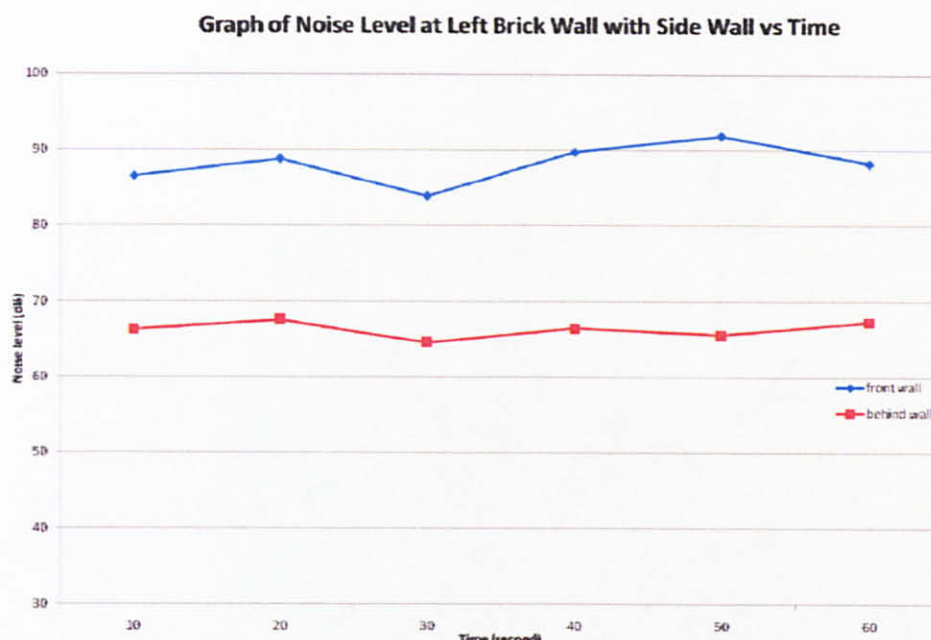
Figure 4.16: Graph of noise level at centre brick wall with side wall vs. time

Figure 4.17: Graph of noise level at right brick wall with side wall vs. time

Figure 4.18: Graph of noise level at left brick wall with side wall vs. time

Based on the three graphs, the noise reduction is more consistent compared to the barrier wall without side wall. It can be justified that the noise reduction at the centre of wall is lower compared to other locations which are right and left as the noise is reflected back by the side wall. It is not only will create louder noise, but also high noise reduction. However, the difference between the three locations is not big as the wall is constructed in small scale of dimension. The average noise reduction for three locations is **19.87 dBA** which greater than barrier wall without side wall. The real barrier wall may have or not the additional side wall since the purpose of introducing the side wall in this study is to prohibit influence of generated noise. The field measurement at Ipoh-Utara Highway barrier wall achieved 9.5 dBA while the new potential barrier wall using crumb rubber-added brick managed to get greater noise reduction. Therefore, crumb rubber is a good material compared to the concrete in terms of sound absorption.
